S&S HOME INSPECTIONS, LLC

Home Inspection Report

545 Sycamore Dr.
Drexler, KS 67814

Inspected On Sun, Jan 25, 2026 at 9:00 AM

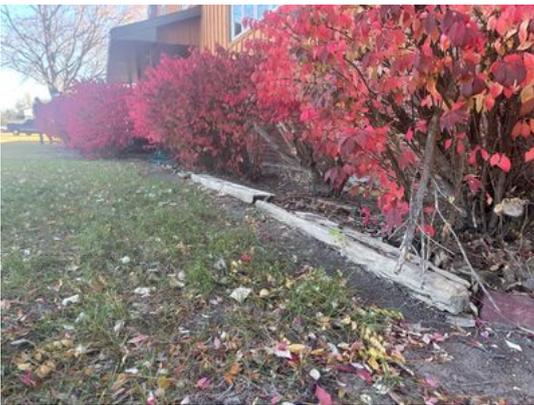
While most of the grading is sloped away from the house, this area in front does have negative grading towards the foundation. We recommend bringing in additional backfill to ensure proper drainage away and that water cannot collect against the foundation.

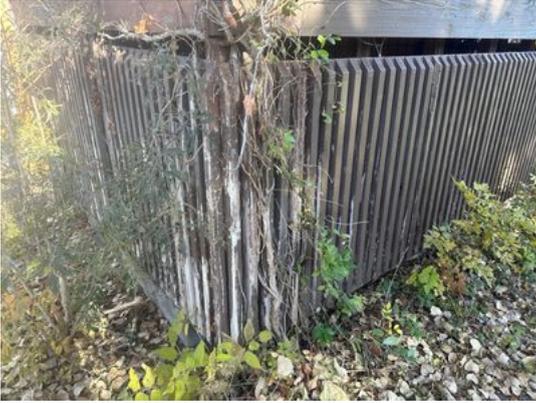
Vegetation

We recommend keeping vegetation trimmed off of building components, especially wood, to prevent unnecessary damage.

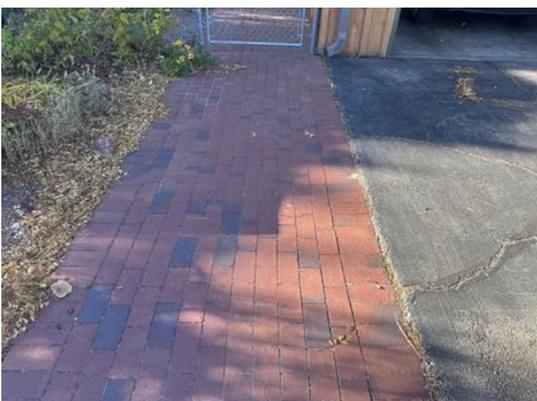
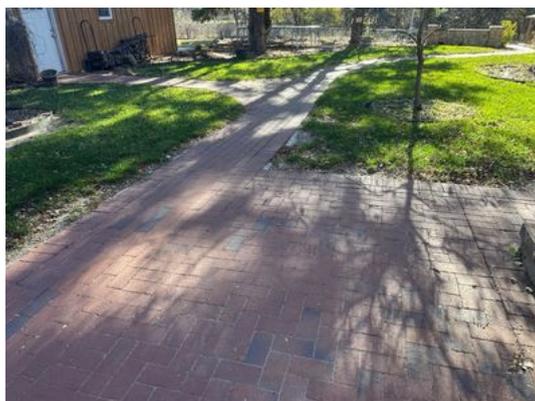
Walkways

This brick walk in front is in satisfactory condition but will require some maintenance before it worsens.

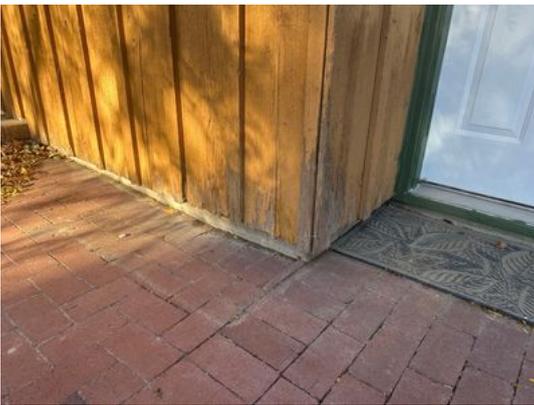
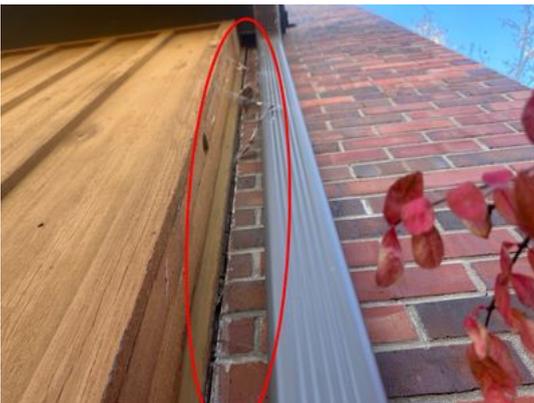
Exterior Covering

The siding is in overall satisfactory condition. However, some minor repairs/sealing may be required. This type of siding will require routine maintenance and new sealant/paint every few years to prevent damage.

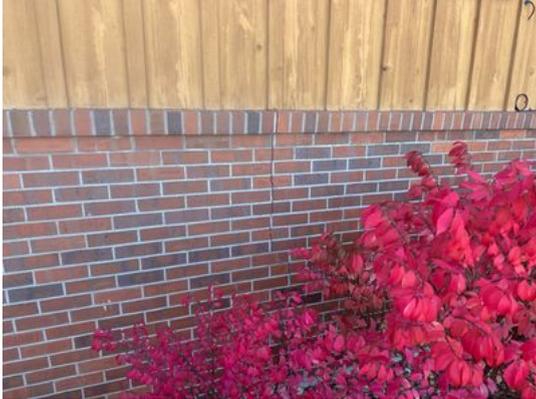
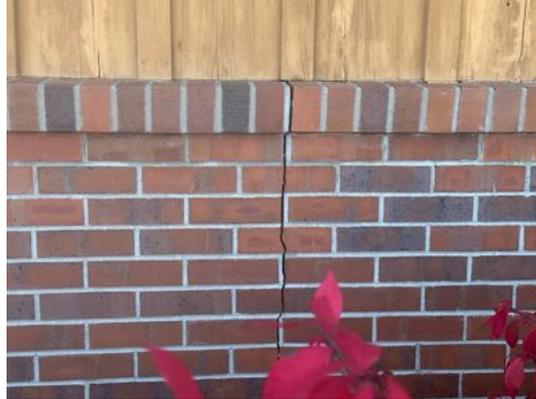
Some cracking in the brick siding. We recommend sealing to prevent moisture intrusion and worsening.

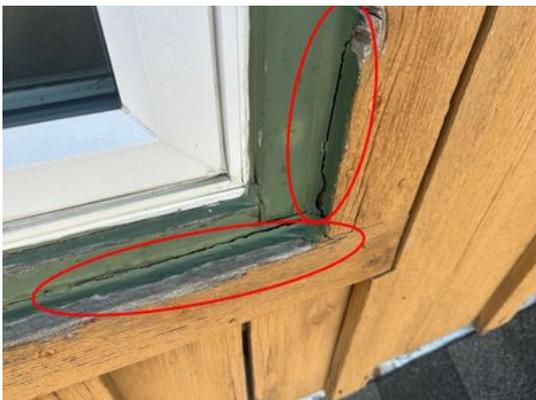
Windows

The wood portions of the windows will require some minor touchups as well as routine sealing/painting.

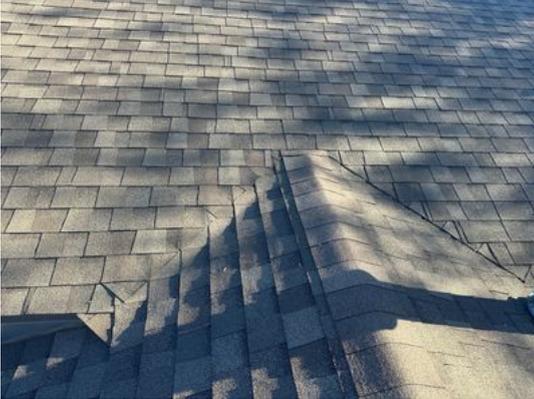
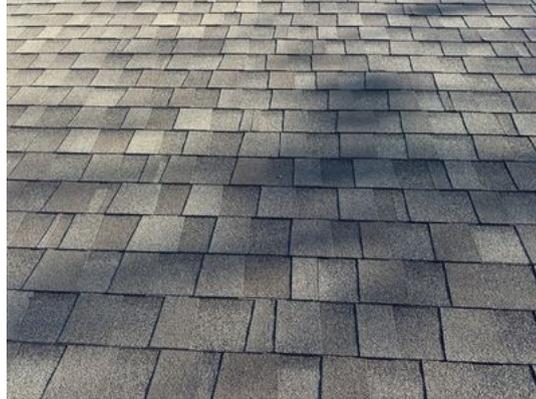
The roof covering appeared to be doing its job and was in overall satisfactory condition.

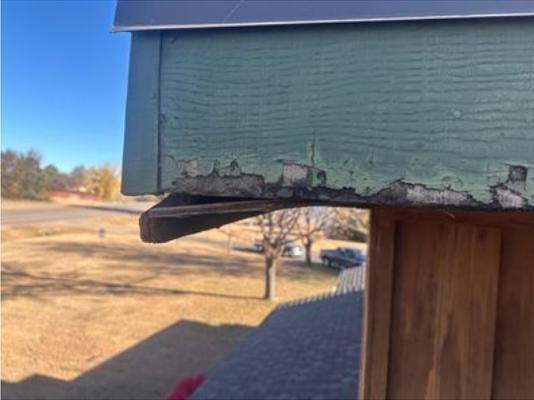
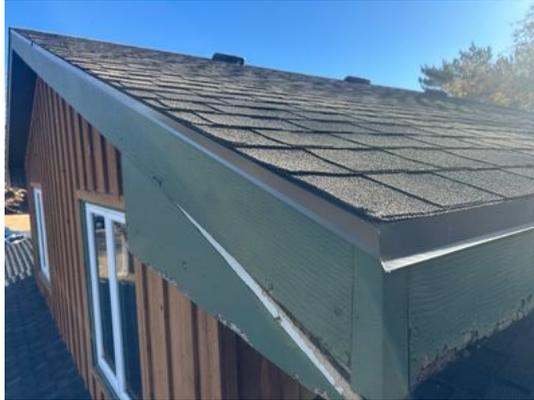
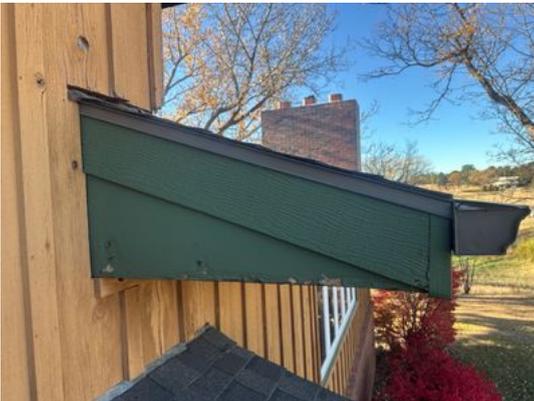
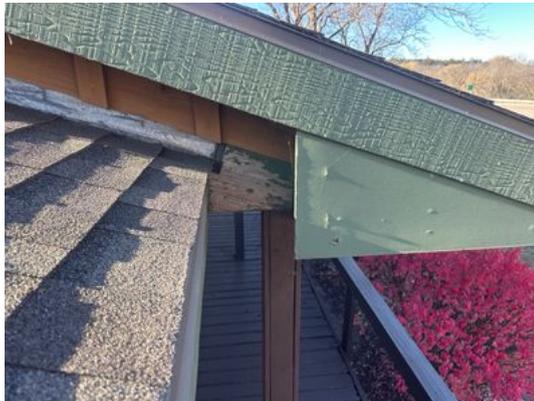
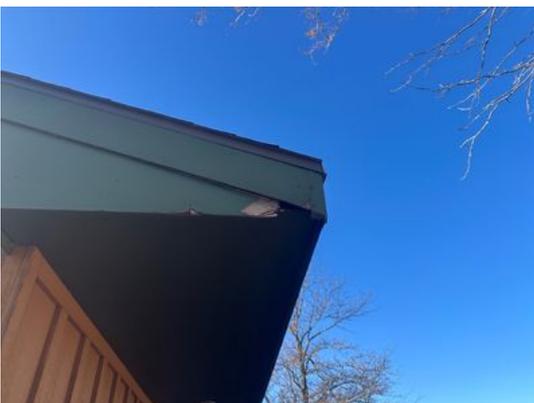
While the soffit and fascia areas are in overall satisfactory condition, some minor repairs/painting will be required. Also, this is something that will require routine maintenance to prevent worsening.

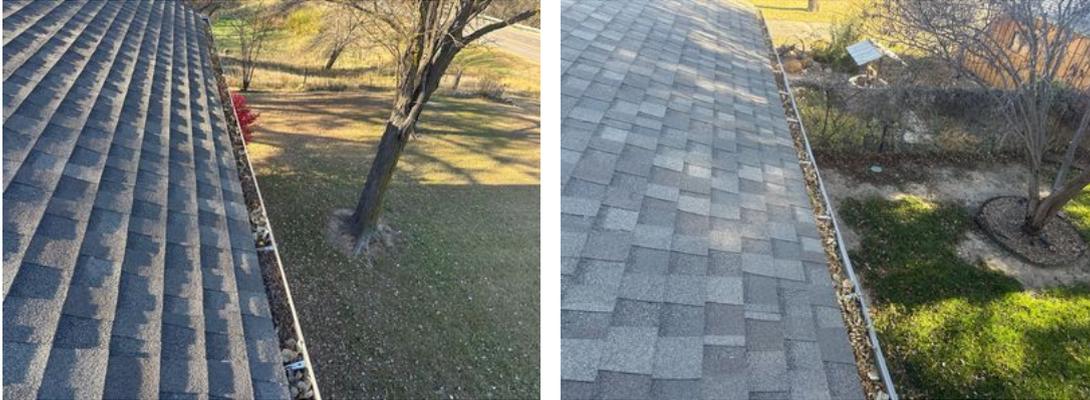
**Comment 9
Information**

The gutters will need cleaned to allow proper operation. With this many trees present, it might be a good idea to install leaf guards of some kind.

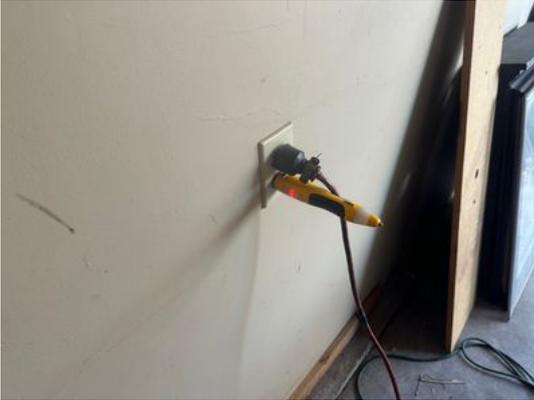
Condition: Repair or Replace

It is a good idea for garage receptacles to be GFCI protected, especially when not grounded, as this one is.

When possible, it might be a good idea to install additional GFCI protected receptacles for service and convenience. This can also help deter the use of extension cords as permanent or prolonged power.

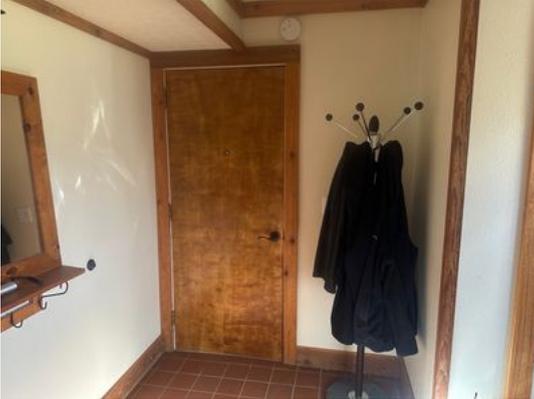
We could not verify a fire rating for this door and it was missing an auto close function. Repair as you see fit.

Fire separation measures (auto close function on the house door, fire rated door, fire rated material on shared walls and the ceiling, sealed holes/gaps, etc.) can help to keep the house isolated from the garage in the event of a fire within the garage. This can also help to insulate the house from the garage temperatures. We recommend maintaining complete fire separation.

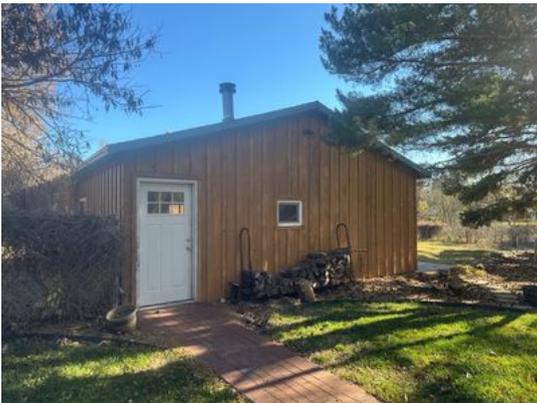
Comment 16
Information

These buildings were briefly inspected and found to be in overall satisfactory condition.

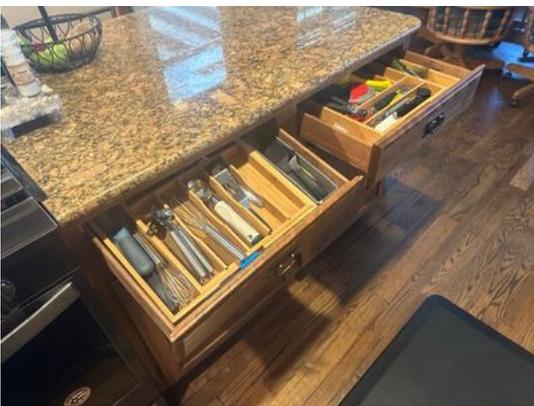
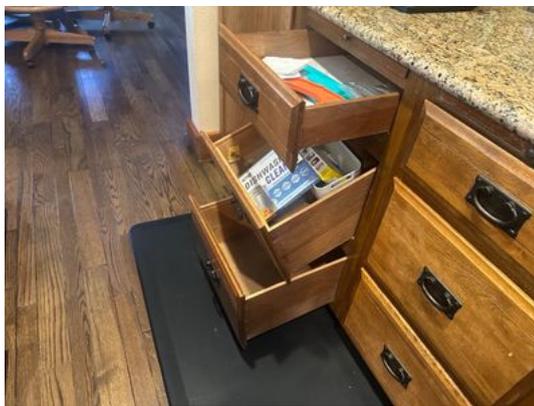
Comment 17 Information

Some drawer slides will require repair/replacement.

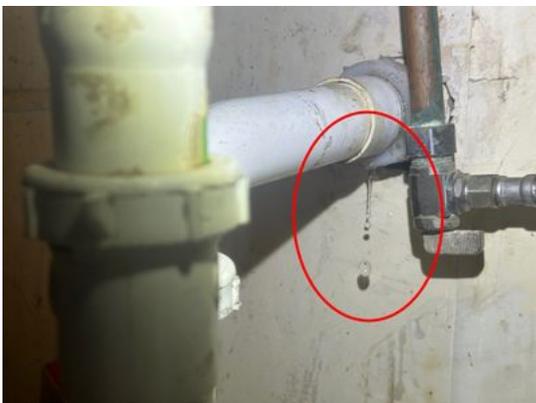
Functional Drainage

Condition: Repair or Replace

The drain was leaking during the inspection.

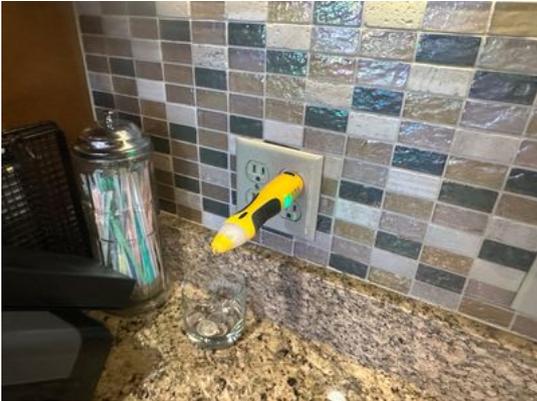
Comment 20

Receptacles Present

Yes, GFCI Protected, Recommend GFCI

Condition: Repair or Replace

We strongly recommend any receptacle that is within 6' of a water source or that serves a countertop be GFCI protected.

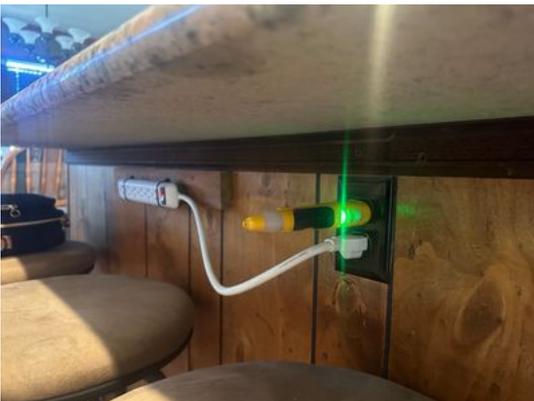
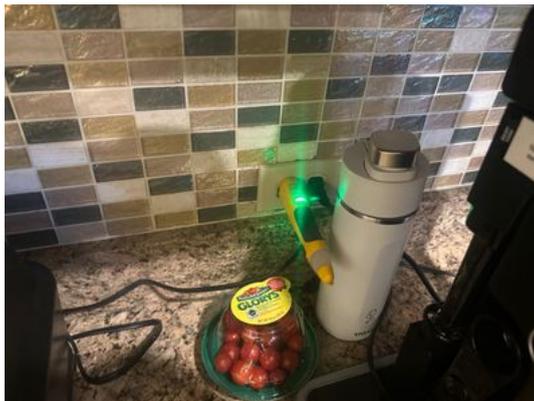
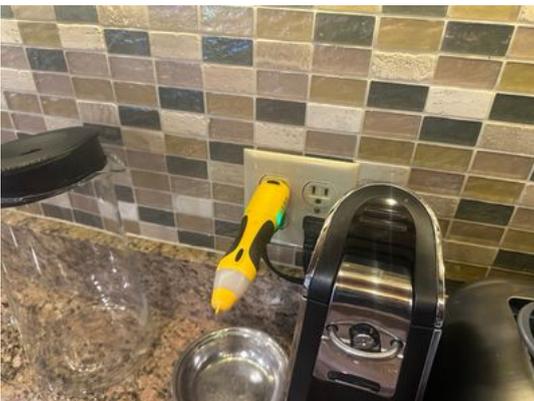
Comment 21
Information

All of these GFCI receptacles are connected. While they are functioning as expected, all of them need to be reset if one of them trips. Repair as you see fit.

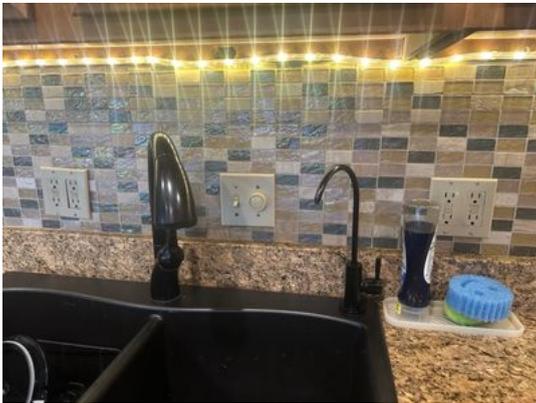
Comment 22
Information

Unidentified Switches

Condition: Further Evaluation Required

We could not determine a use for these switches.

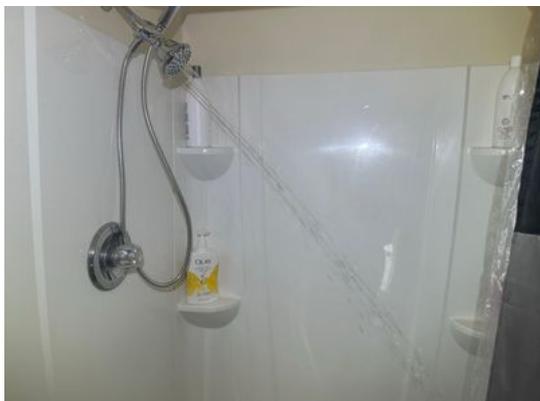
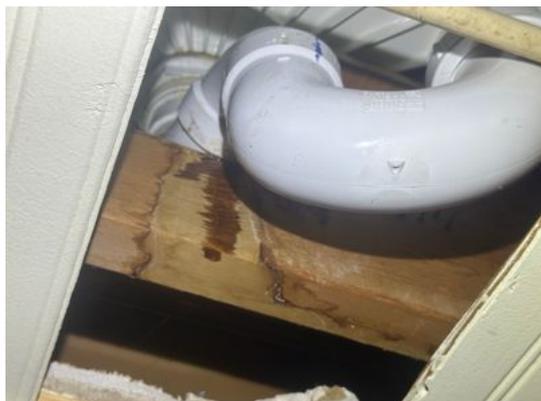
Comment 25

The drain was leaking during the inspection.

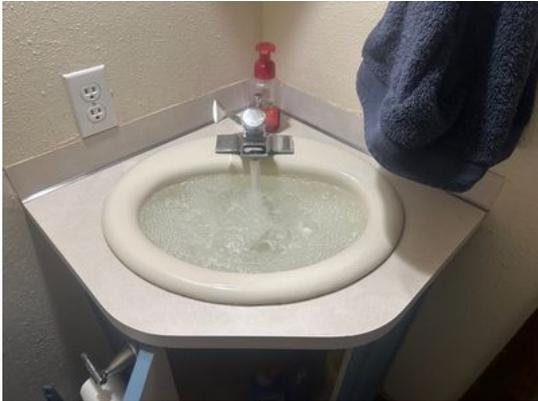
Comment 27

While there were no leaks present, there is quite a bit of corrosion. Replacement may be required in the near future to prevent unexpected leaks.

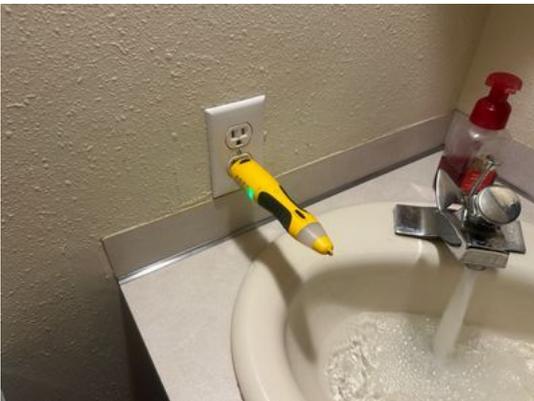
Yes, Working, Recommend GFCI

Condition: Repair or Replace

We strongly recommend bathroom receptacles be GFCI protected.

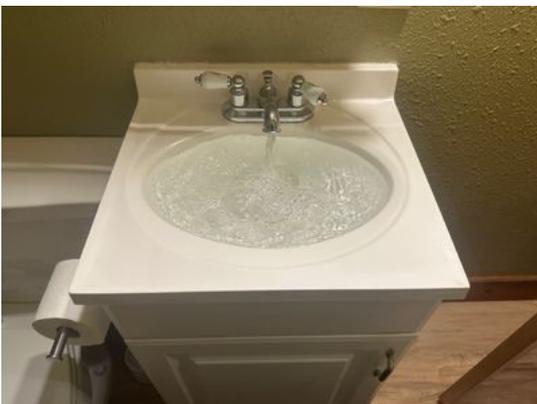
**Comment 29
Information**

This bathroom sink does not have an overflow drain. Do not leave filling unattended. The drain stopper was not installed.

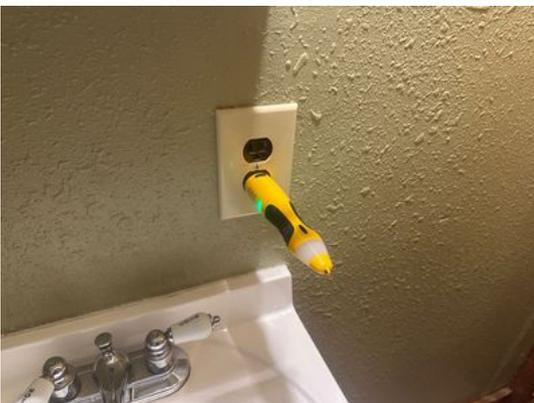
Deficiency

We strongly recommend bathroom receptacles be GFCI protected.

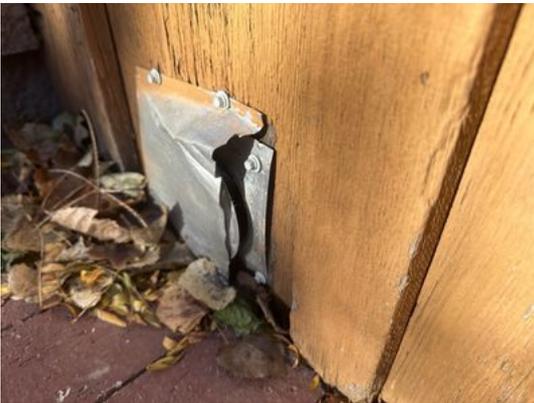
Comment 33
Information

The dryer exhaust hood is smashed, which could severely limit air flow. We recommend repair.

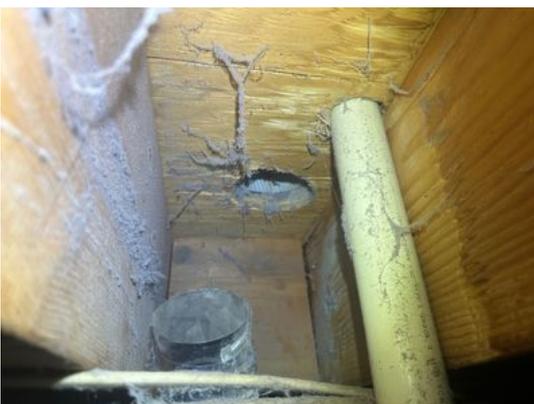
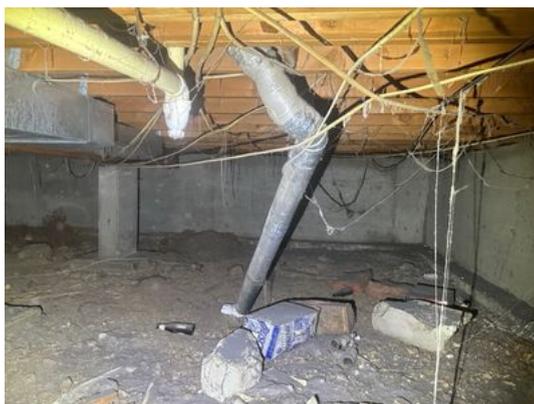
Comment 34
Information

The dryer vent is not connected and is venting into the crawlspace. We recommend repair.

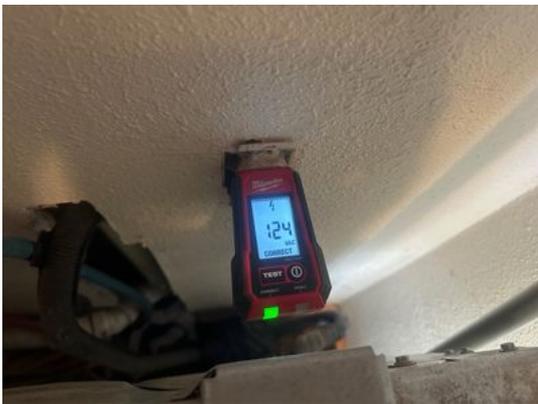
Receptacles

Yes, Broken/Missing Cover Plates

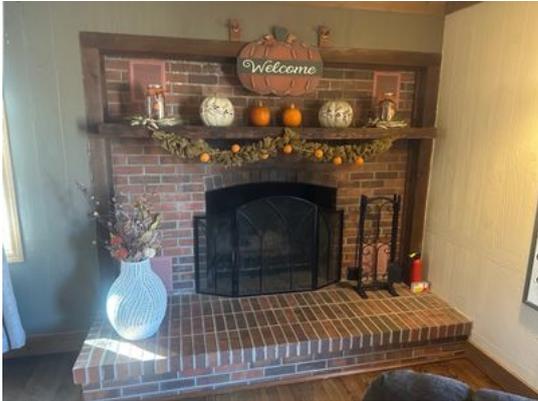
Comment 38

The fireplace appeared to be in overall satisfactory condition. It was indicated to us that it has been cleaned in the last few years. If use is desired, we recommend continuing this every few years to maintain its condition and ensure safe and proper operation.

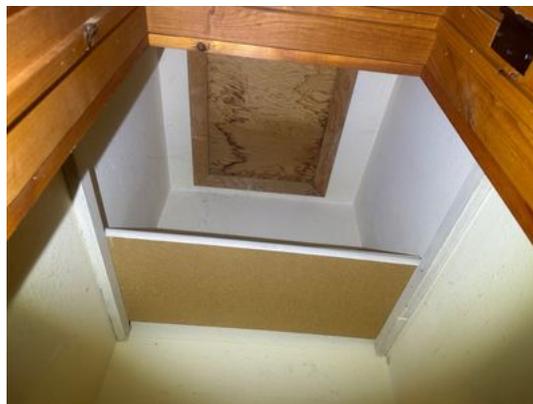
Comment 39 Information

The closet and access opening are very small and difficult to navigate.

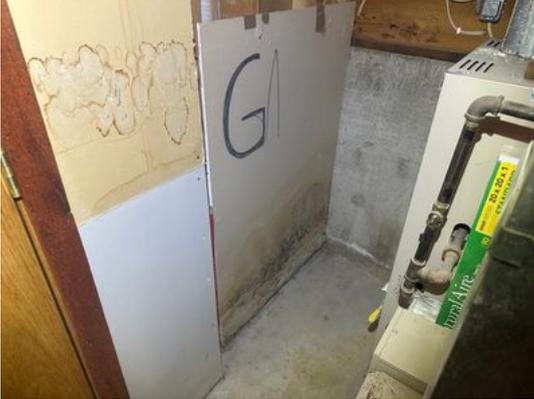
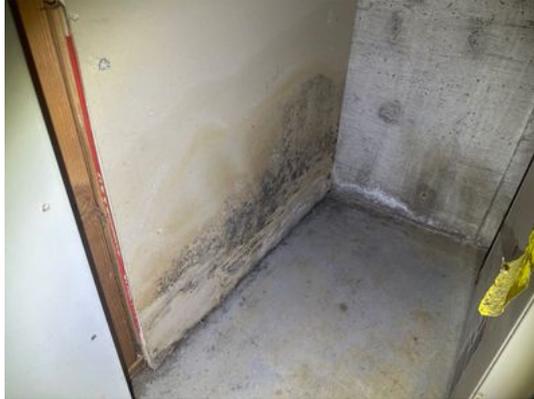
Comment 40
Information

This piece of drywall in the mechanical room has mold like stains present. We recommend removing.

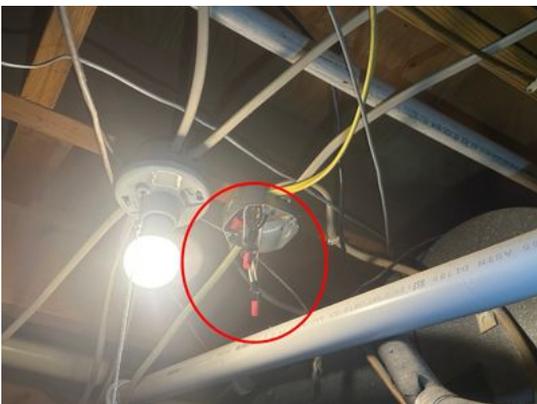
No Apparent Defects, Broken/Missing Cover Plates

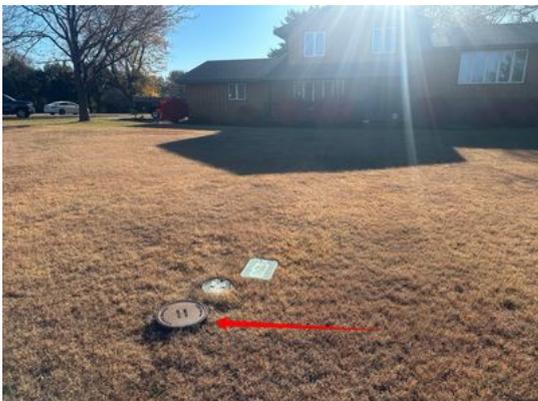
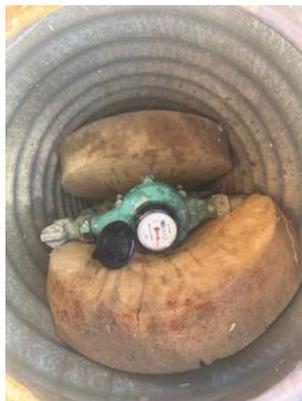
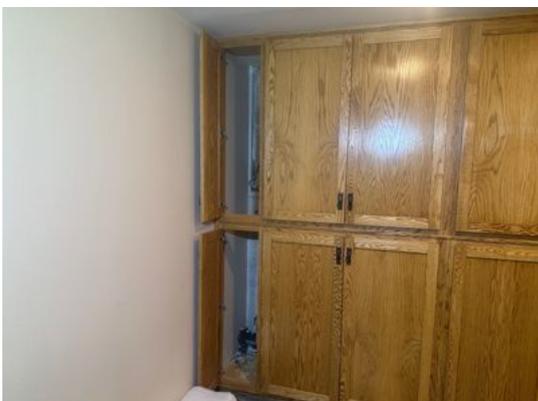
Location of Main Water Shutoff

At Meter, Basement

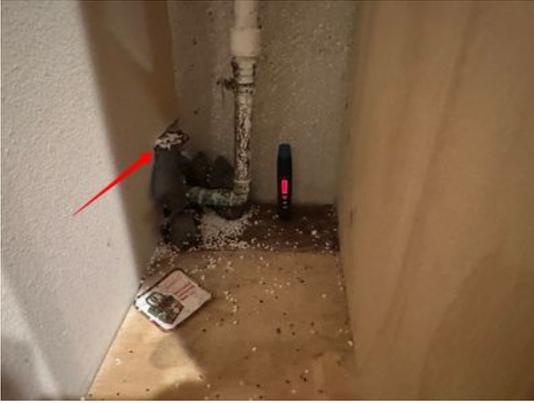
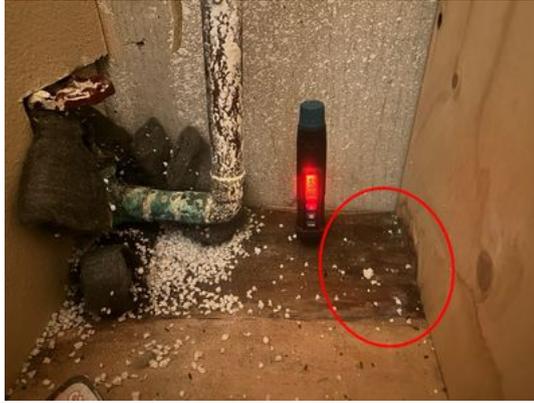
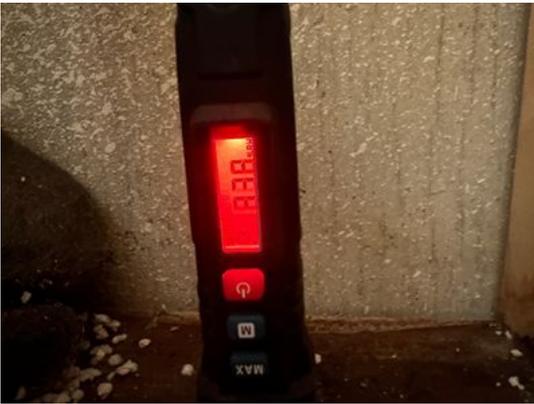
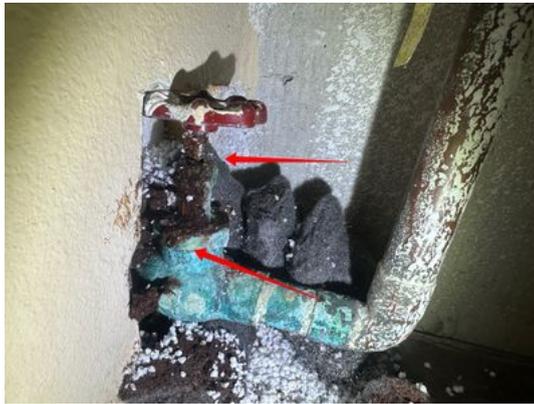
Comment 44
Information

We recommend removing additional drywall to create easy access to this shut off. Also, the gate valve was leaking, leaving the wood very wet and there are signs of possible mold growth.

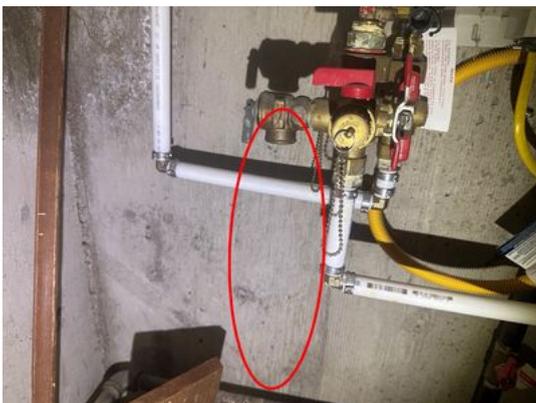
Temp & Pressure Relief Valve

Present, No Extension, Recommend Extension

Condition: Repair or Replace

We recommend installing an extension here that terminates within 6-24" off the floor or into a drain to protect from injury should the valve open.

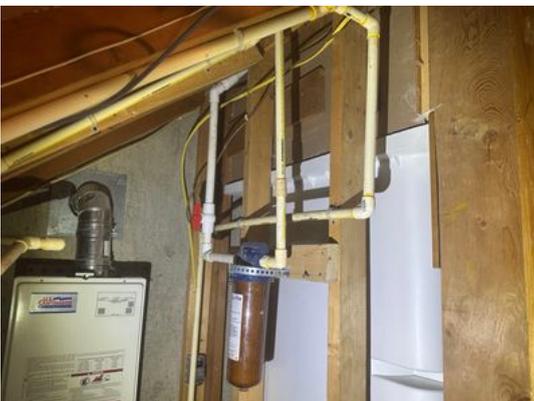
**Comment 46
Information**

There is also a whole house filter in place.

Water filtration filters should be changed about every 6 months, depending on usage.

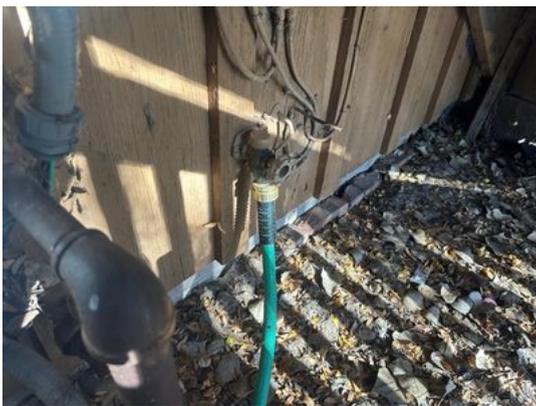
Comment 49
Information

This faucet in the front will require repair or replacement.

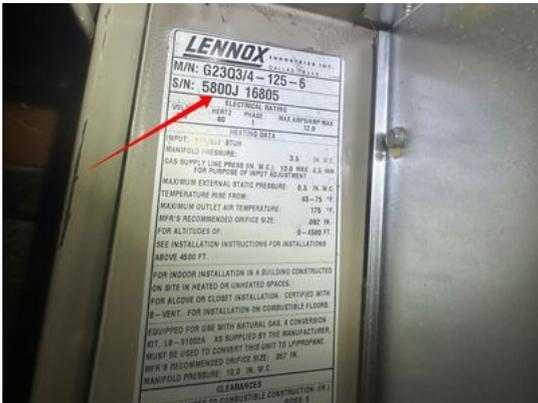
**Comment 51
Deficiency**

25 Years - September 2000

Aging Furnace

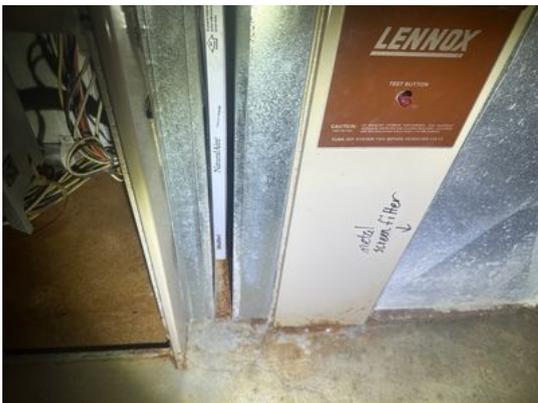
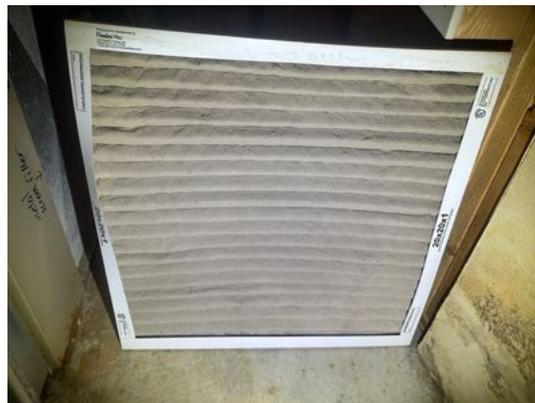
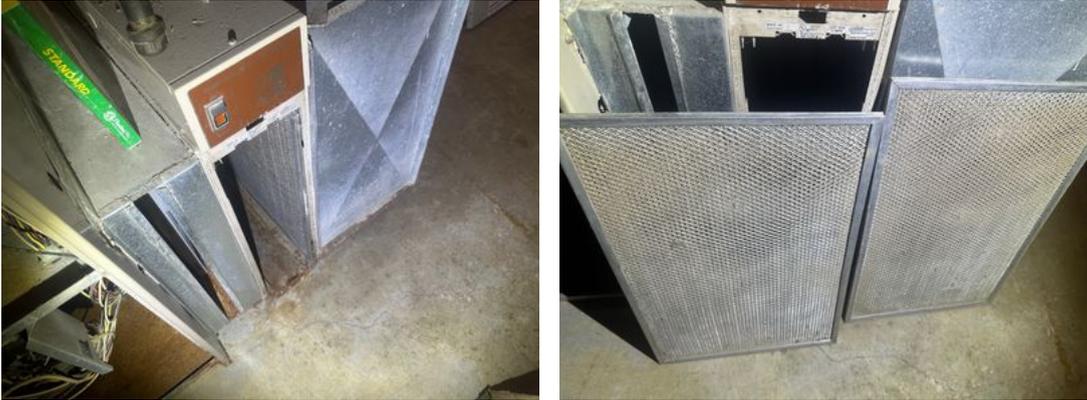
Comment 53
Information

Standard, Needs Cleaned/Replaced

Condition: Repair or Replace

The filter that's installed is too small. We recommend installing a properly sized one to maximize efficiency and longevity.

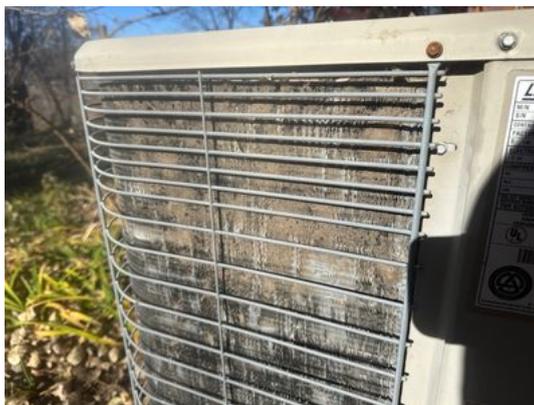
**Comment 55
Information**

Condition: Marginal

The fins have quite a bit of debris which can severely limit air flow and efficiency. We strongly recommend having the system cleaned.

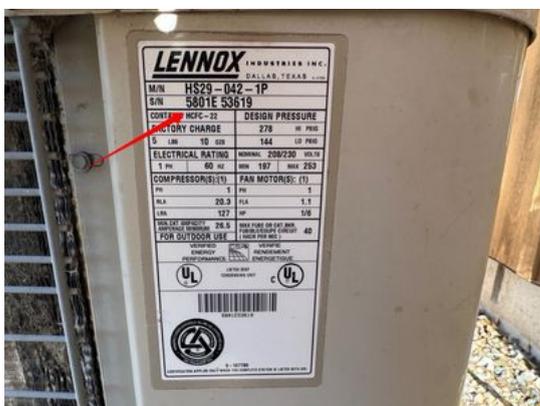
**Comment 56
Deficiency**

24 Years - May 2001

Aging A/C

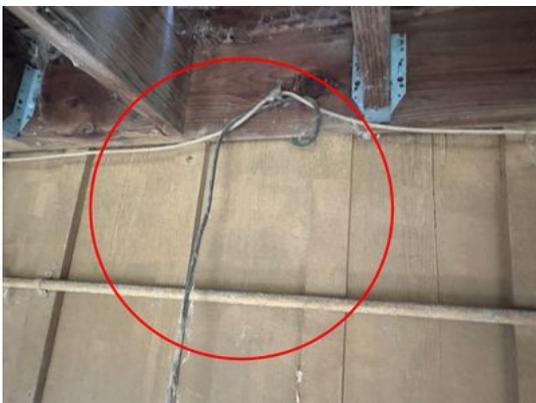
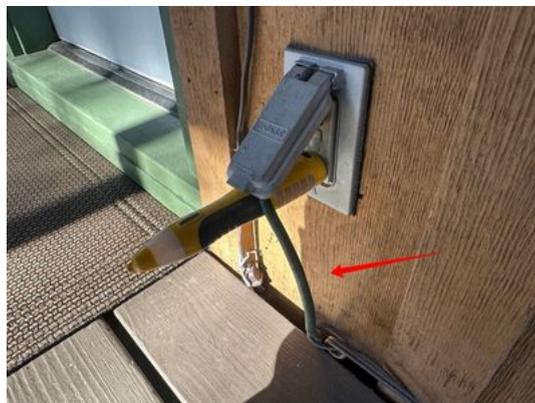
Comment 60 Information

GFCI Protected, Handyman Wiring, Recommend Additional
Condition: Satisfactory

When possible, it might be a good idea to install additional GFCI protected receptacles for service and convenience. This can also help deter the use of extension cords as permanent or prolonged power.
